Preliminary Results from Simultaneous Cryo Test of Three 0.5 m Mirrors

James Hadaway, Joseph Geary, & Lisa Blackwell -
The University of Alabama in Huntsville

Ron Eng, Phil Stahl, John Hraba, Gary Thornton
Ken Whitley, & Jeff Kegley - *Marshall Space Flight
Center*

May 23, 2002

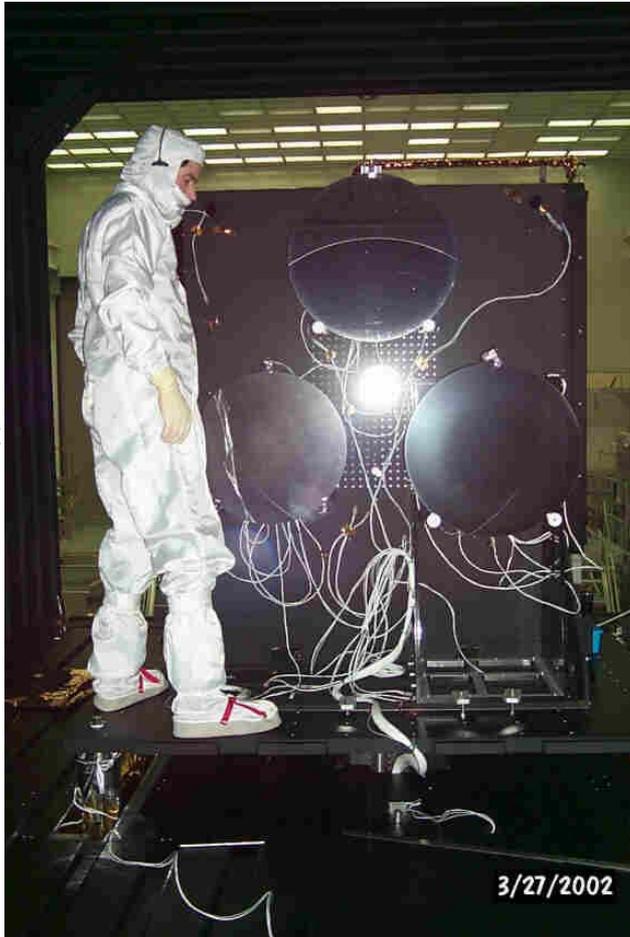
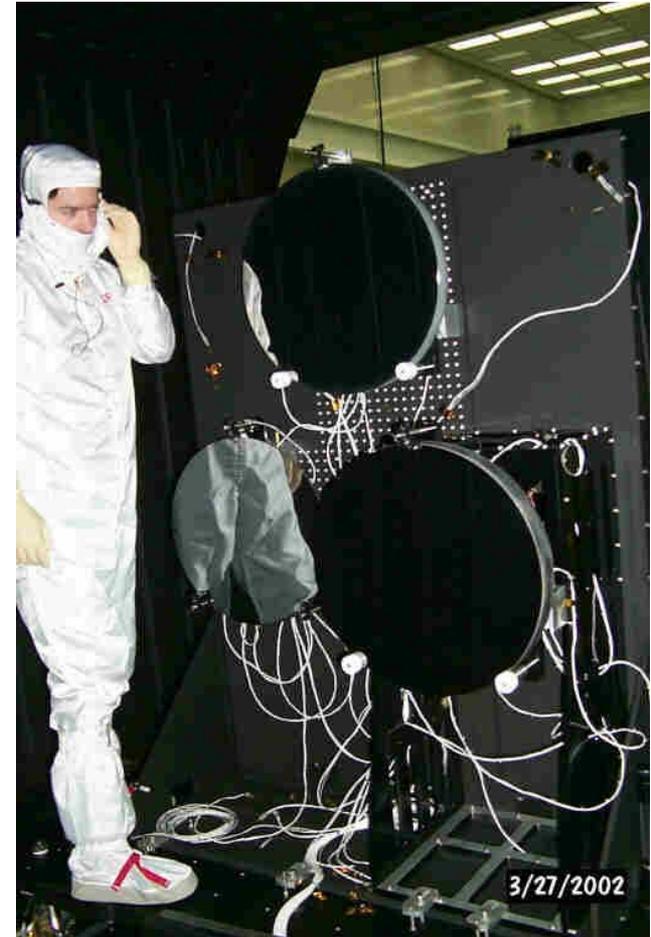
3-Mirror Test Set-Up

- Had three 0.5 m diameter, 20 m radius lightweight mirrors from various sources:
 - 8 kg/m² C/SiC from IABG (tested once previously)
 - VHP Joined-Beryllium from Brush-Wellman/Goodrich
 - 22 kg/m² SiC from Xinetics
- Developed test stand to hold all three mirrors to enable simultaneous cryo testing.
- Particularly interested in:
 - Repeatability of C/SiC cryo deformation (previously tested)
 - Print-thru of Joined-Be
 - Performance of SiC versus C/SiC

JBe

C/SiC

SiC

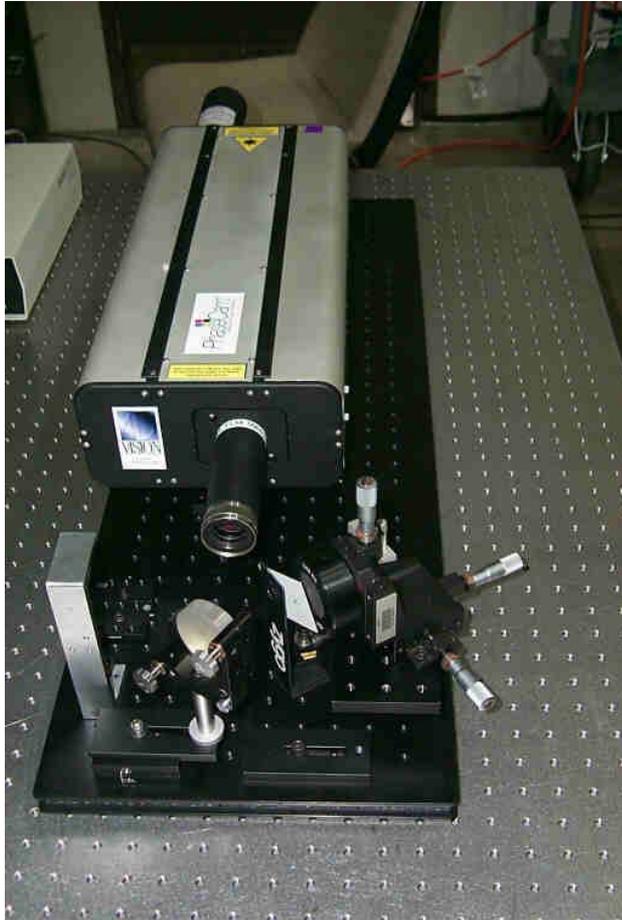
PhaseCam Pallet

- PhaseCam interferometer with F/33 diverger.
- Reference sphere for subtraction of instrument errors.
- Intellwave software.
- Leica Disto Pro distance meter for RoC.
- Pallet atop Hexapod 6-DOF platform (pivot point set at common mirror CoC).

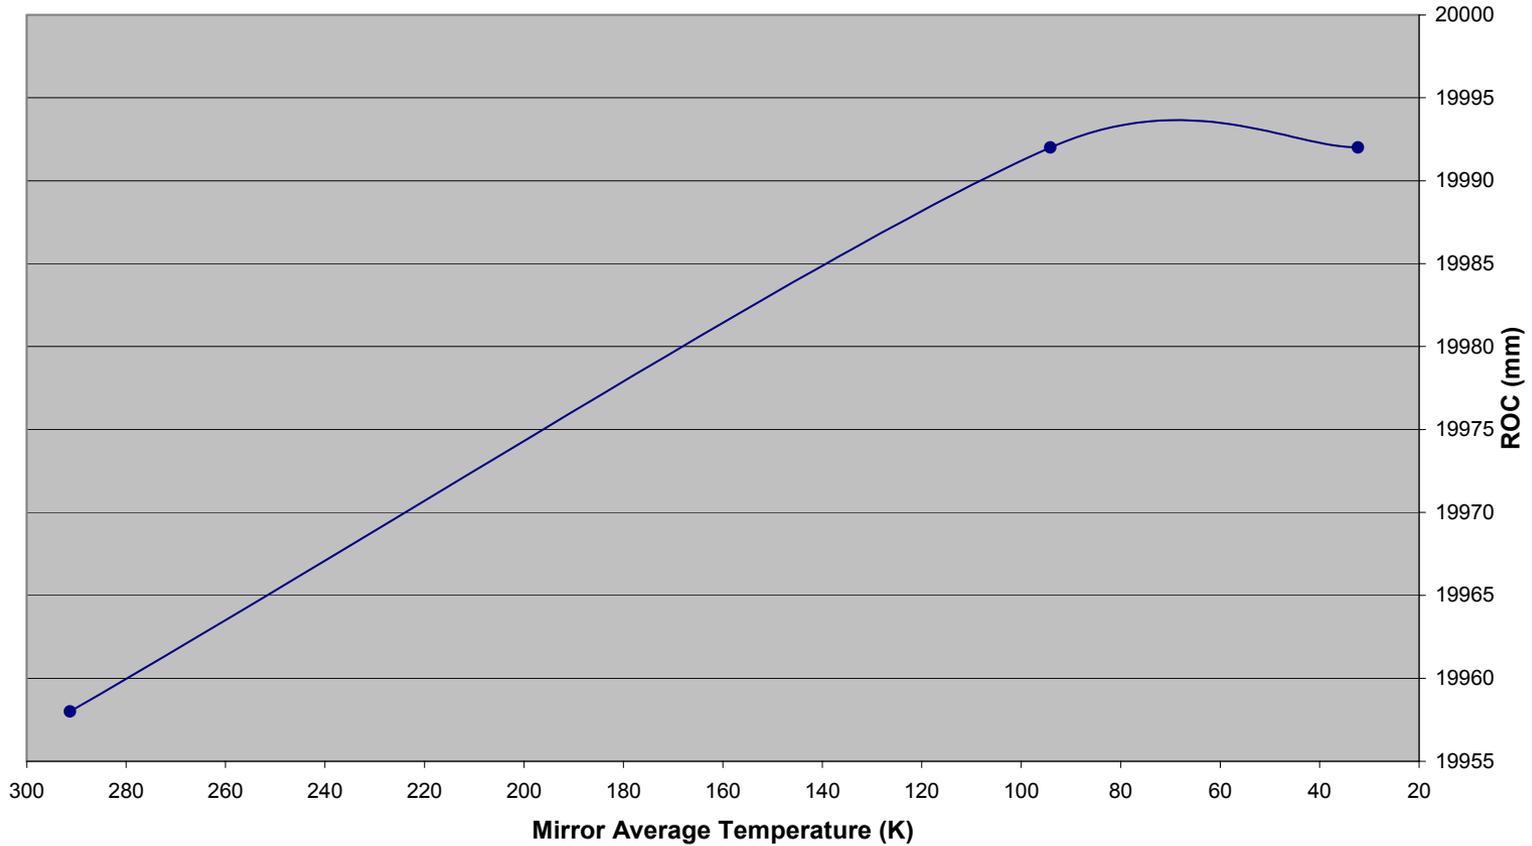
C/SiC RoC vs Temperature

CSiC - ROC

- RoC increase of 35 mm is unexpected.
- Changes tend to level off between 100 & 150 K, corresponding to level off of SiC CTE.
- Total surface figure change of about 0.7 waves (443 nm) RMS. Mostly astigmatism due to felt lay-up during fabrication. Saw 81 nm RMS for SBMD.
- High-frequency surface figure change of about 0.08 waves (51 nm) RMS, or 0.05 waves (32 nm) RMS without edge effects. Saw 16 nm RMS for SBMD. Can see some print-thru of ribs, but also a more random-looking component.
- Difference of 0.016 waves (10 nm) RMS between pre & post-cryo ambient figure - astigmatism. Need to check for measurement errors before concluding that a permanent change occurred.
- RoC & RMS figure changes same as in first test. PV figure changes about twice first test (may be due to different masking, shape looks same).

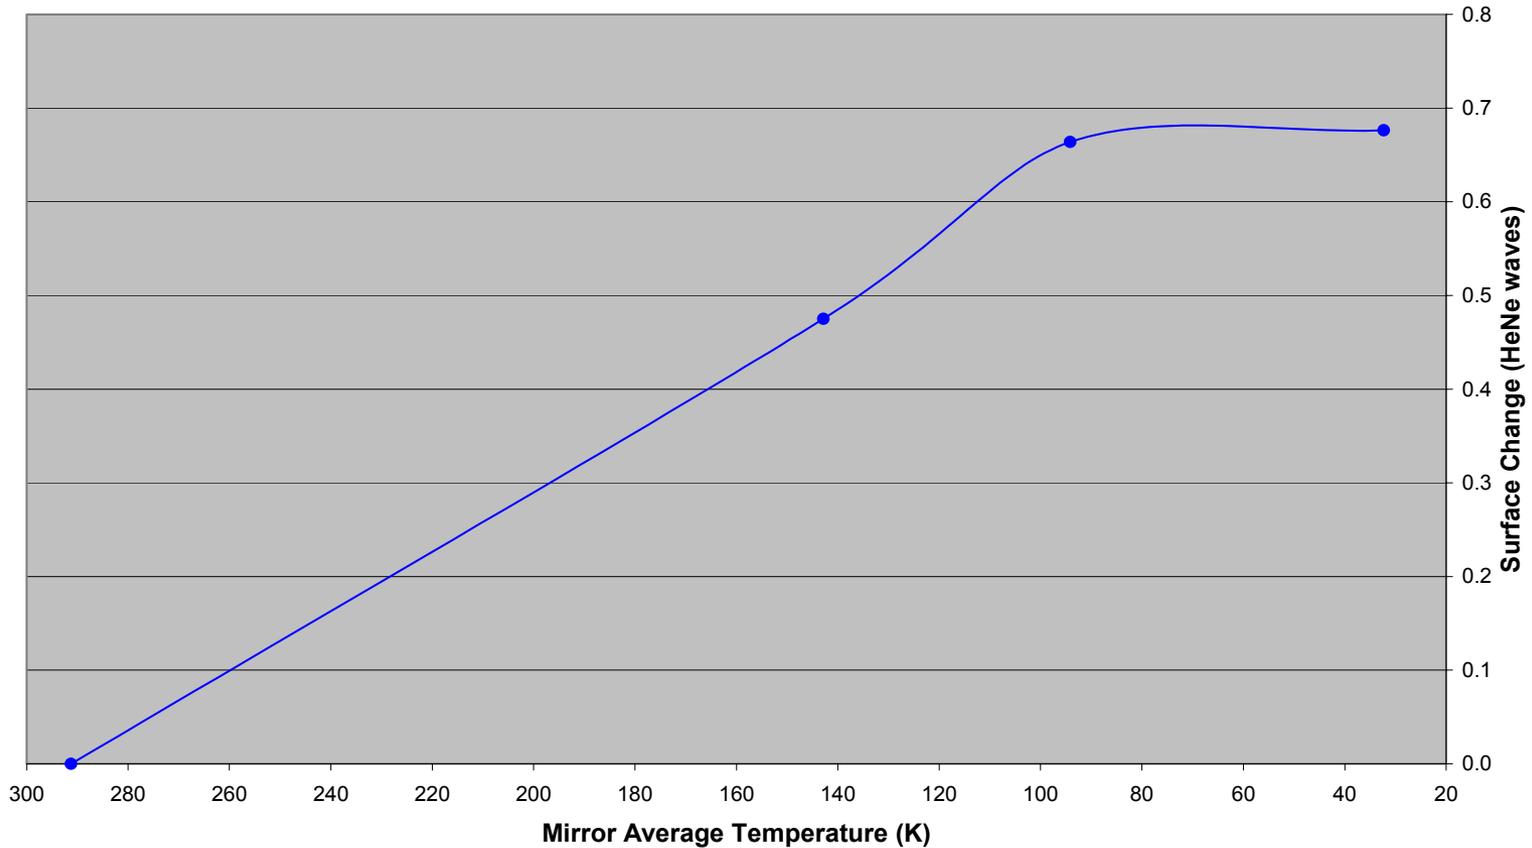
C/SiC RMS Cryo Deformation vs Temperature

CSiC - RMS Surface Change from 291 K

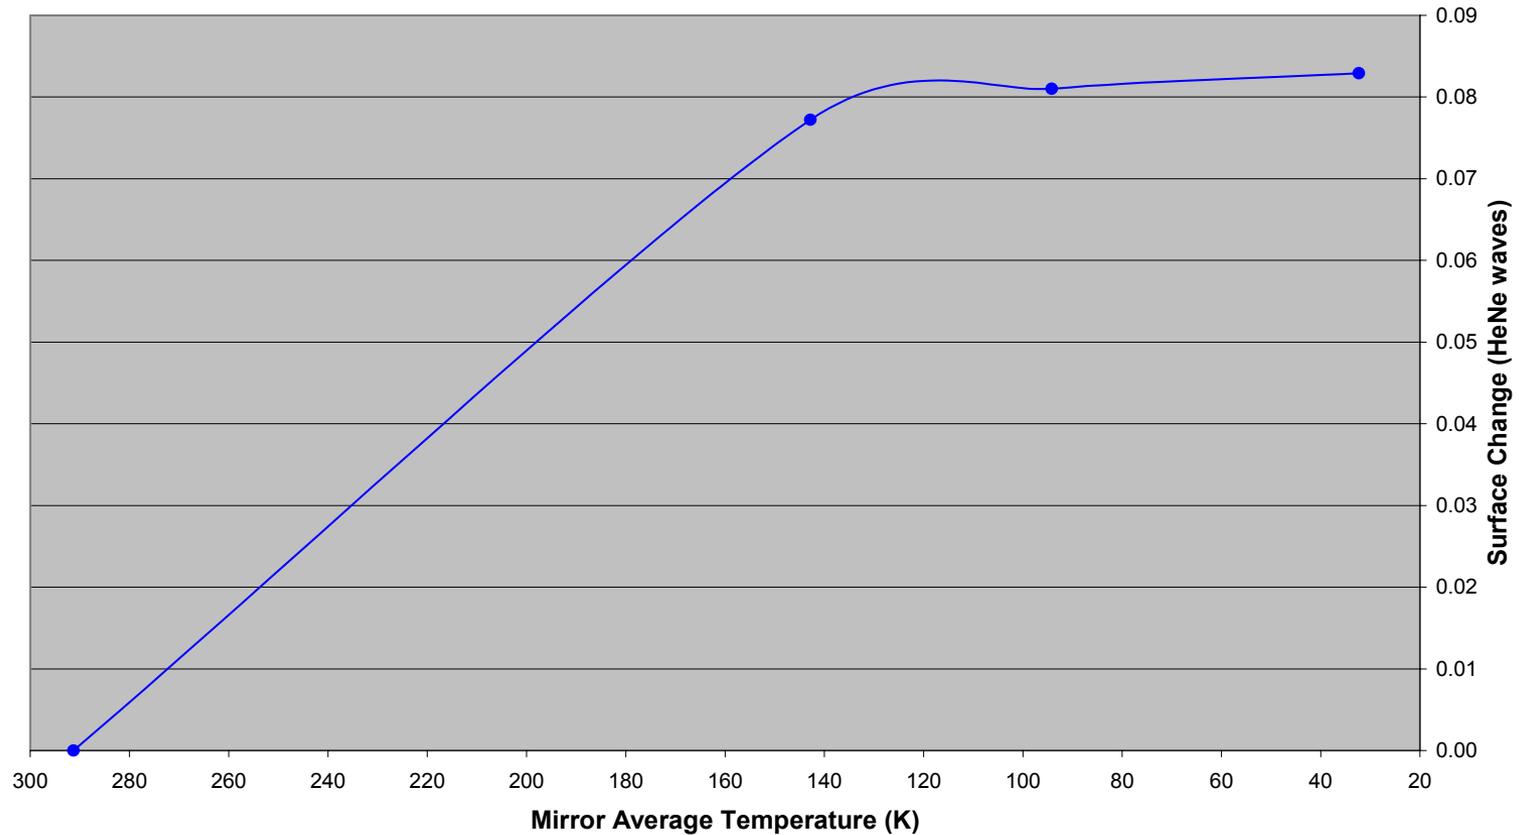
C/SiC RMS Residual Cryo Deformation vs Temperature

CSiC - RMS Residual Surface Change from 291 K

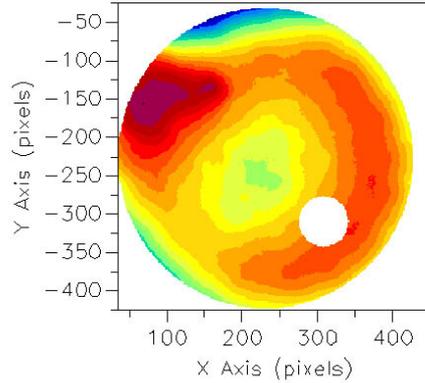
C/SiC Ambient Figure

IntelliWave: Surface Map [4AM.TMD]
Date Acq: 04/02/02, 15:22:37
FILE: CSIC_VAC_291A_REF_MSK3.ESD

Range (PV) = 2.1818 waves, RMS = 0.3031 waves, Strehl = 0.0266
Analysis Aper: Pos[232, 228] Size[394, 394]

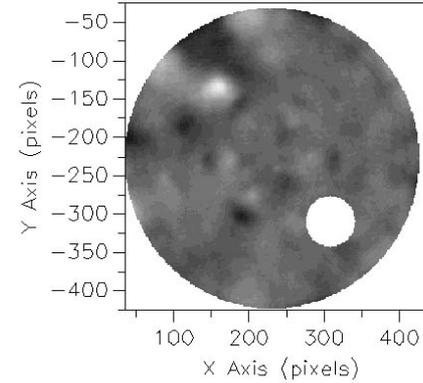
IntelliWave: Surface Map [4AM.TMD]
Date Acq: 04/02/02, 15:22:37
FILE: CSIC_VAC_291A_REF_MSK3.ESD

Range (PV) = 0.4865 waves, RMS = 0.0443 waves, Strehl = 0.9255
Analysis Aper: Pos[232, 228] Size[394, 394]

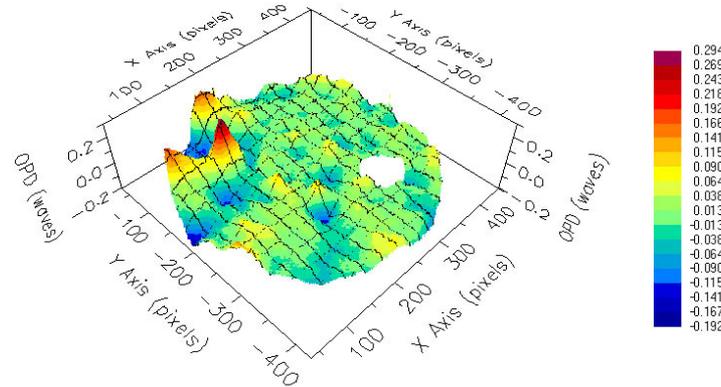
IntelliWave: Surface Map [4AM.TMD]
Date Acq: 04/02/02, 15:22:37
FILE: CSIC_VAC_291A_REF_MSK3.ESD

Range (PV) = 0.4865 waves, RMS = 0.0443 waves, Strehl = 0.9255
Analysis Aper: Pos[232, 228] Size[394, 394]

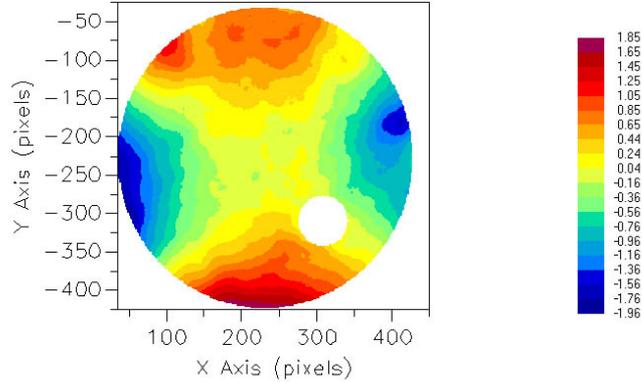
C/SiC Cryo Deformation

IntelliWave: Surface Map [4A.M.TMD]
Date: Acq: 04/02/02, 15:22:37
FILE: CSiC_VAC_33-291A_MSK3.ESD

Range (PV) = 3.8104 waves, RMS = 0.6764 waves, Strehl = 0.0000
Analysis Aper: Pos[232, 228] Size[394, 394]

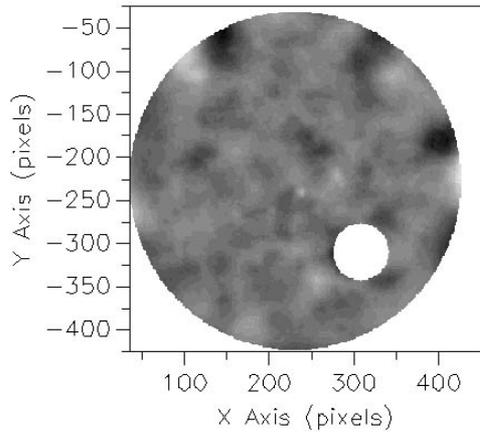
IntelliWave: Surface Map [4A.M.TMD]
Date: Acq: 04/02/02, 15:22:37
FILE: CSiC_VAC_33-291A_MSK3.ESD

Range (PV) = 0.8911 waves, RMS = 0.0829 waves, Strehl = 0.7623
Analysis Aper: Pos[232, 228] Size[394, 394]

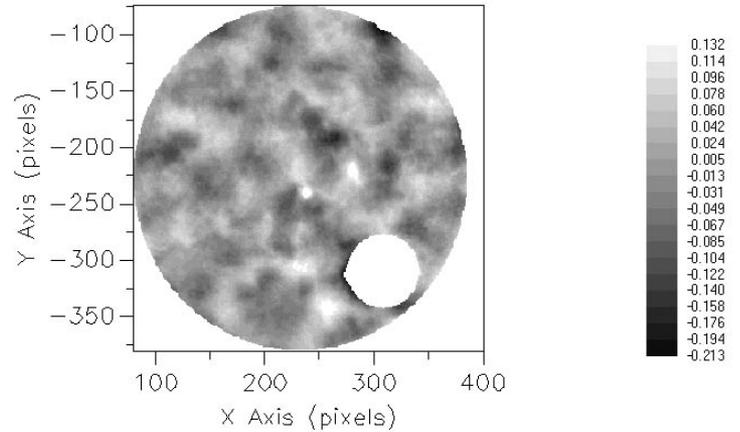
IntelliWave: Surface Map [4A.M.TMD]
Date: Acq: 04/02/02, 15:22:37
FILE: CSiC_VAC_33-291A_MSK4_CLIP.ESD

Range (PV) = 0.3450 waves, RMS = 0.0484 waves, Strehl = 0.9118
Analysis Aper: Pos[233, 228] Size[307, 308]

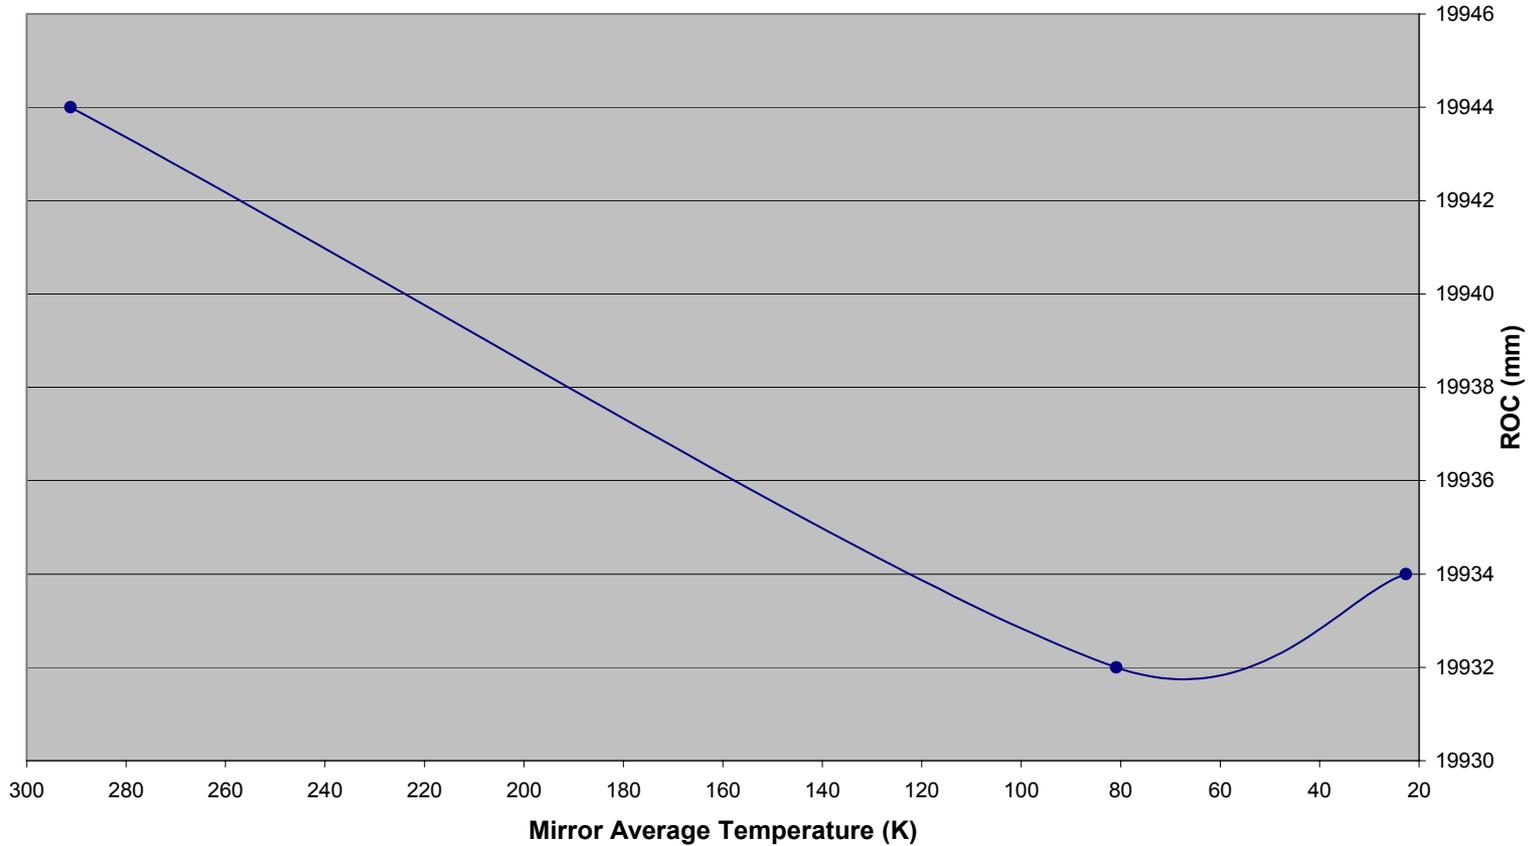
JBe RoC vs Temperature

JBe - ROC

- RoC decrease of 10 mm is less than the expected 26 mm.
- Changes tend to level off around 140 K, corresponding to level off of Be CTE.
- Total surface figure change of about 0.2 waves (127 nm) RMS. Mostly astigmatism, but may actually be “power” changes of left & right halves. Some change around intact portion of joining seam. Saw 81 nm RMS for SBMD.
- High-frequency surface figure change of about 0.02 waves (13 nm) RMS, or 0.01 waves (6 nm) RMS per “pocket”. Saw 16 nm RMS for SBMD. Can see print-thru of ribs, but also a more random-looking component. No real difference between thin & thick rib print-thru.
- Difference of 0.018 waves (11 nm) RMS between pre & post-cryo ambient figure - astigmatism. Need to check for measurement errors before concluding that a permanent change occurred.

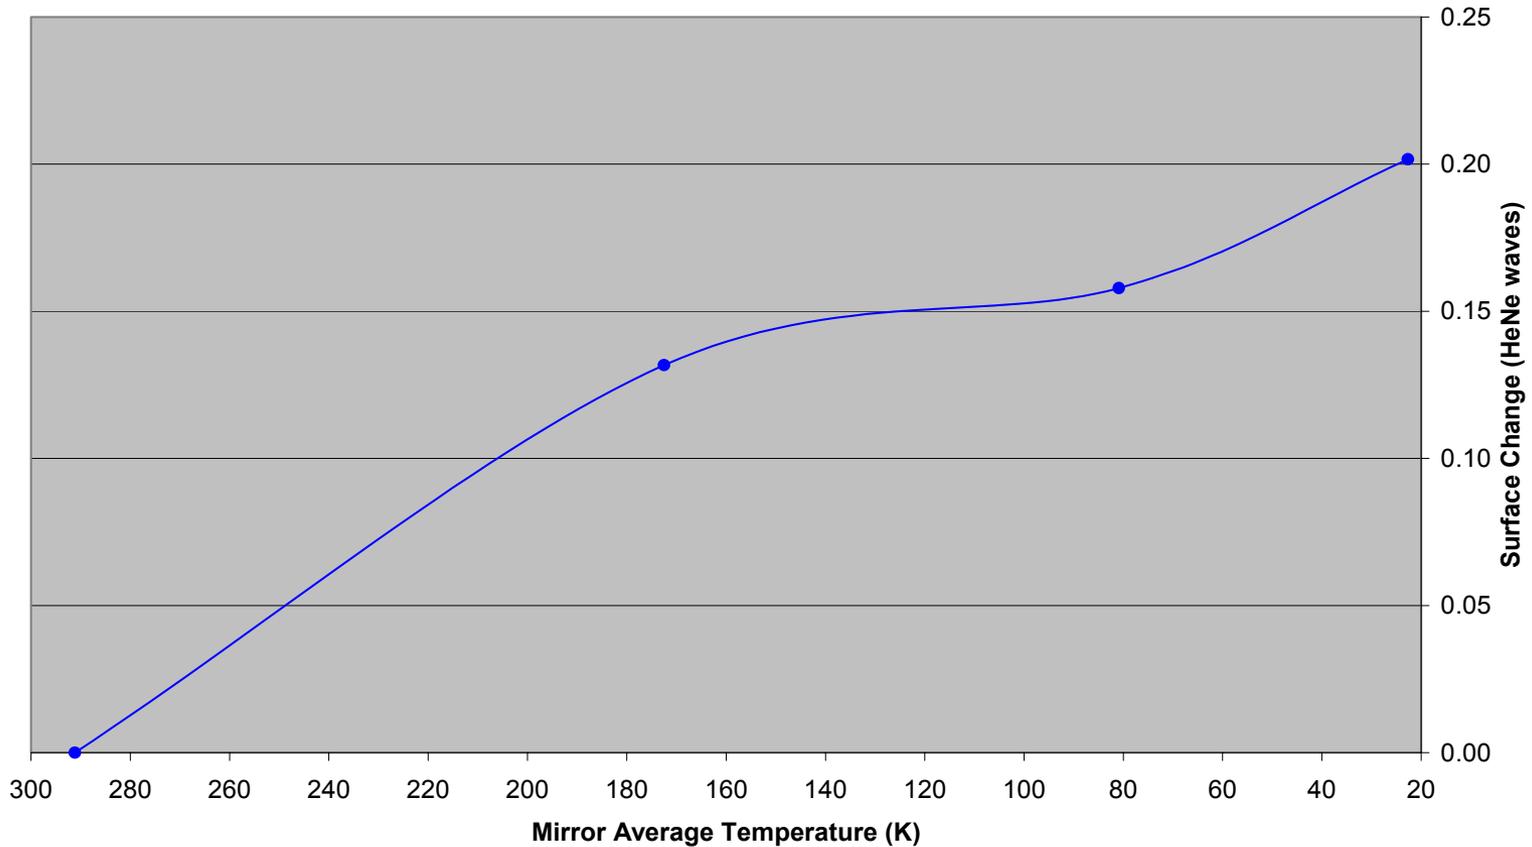
JBe RMS Cryo Deformation vs Temperature

JBe - RMS Surface Change from 291 K

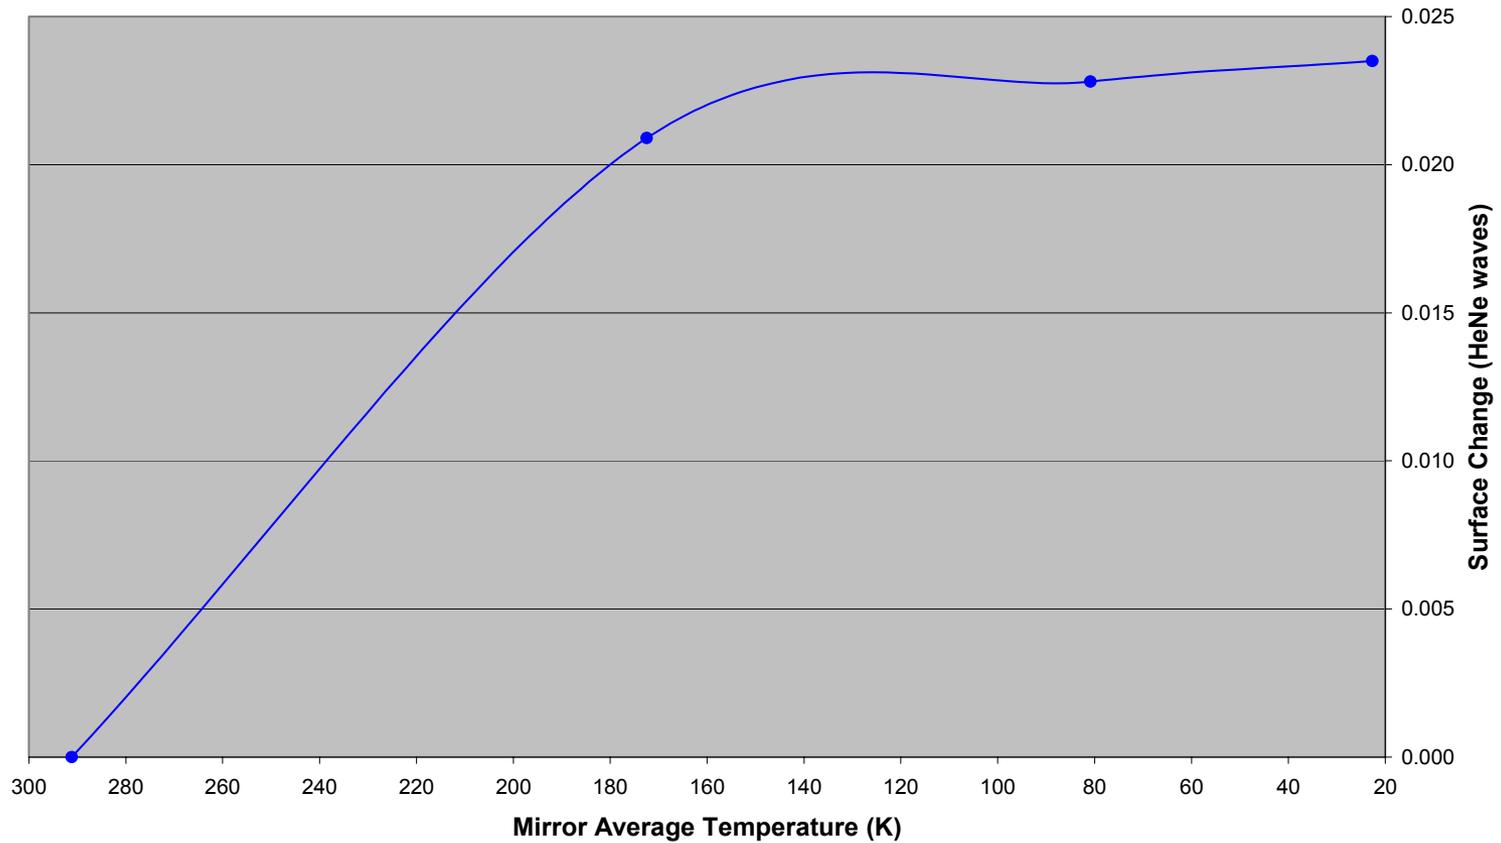
JBe RMS Residual Cryo Deformation vs Temperature

JBe - RMS Residual Surface Change from 291 K

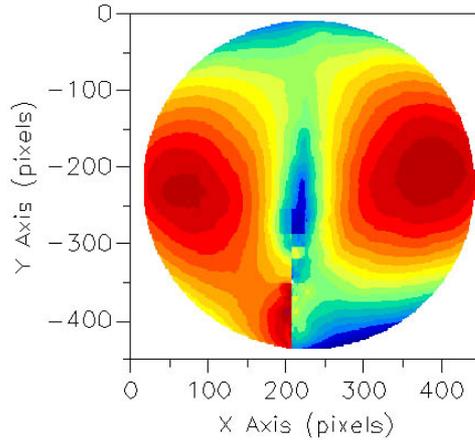
JBe Ambient Figure

IntelliWave: Surface Map [4AM,TMD]
Date: Acq.: 04/02/02, 15:53:10
FILE: JBE_VAC_291A_REF_MSK.ESD

Range (PV) = 4.3472 waves, RMS = 0.8869 waves, Strehl = 0.0000
Analysis Aper: Pos[230, 224] Size[429, 430]

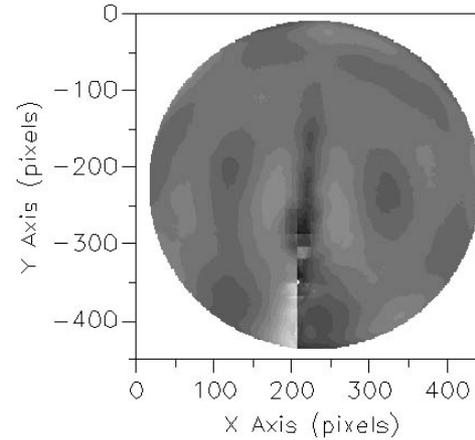
IntelliWave: Surface Map [4AM,TMD]
Date: Acq.: 04/02/02, 15:53:10
FILE: JBE_VAC_291A_REF_MSK.ESD

Range (PV) = 3.7056 waves, RMS = 0.2523 waves, Strehl = 0.0811
Analysis Aper: Pos[230, 224] Size[429, 430]

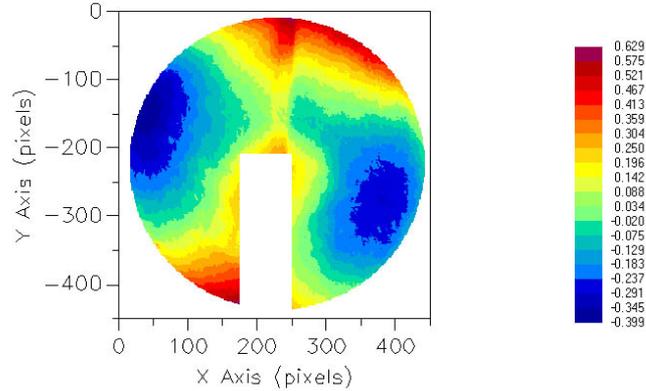
JBe Cryo Deformation

IntelliWave: Surface Map [4AM.TMD]
Date Acq: 04/02/02, 15:53:10
FILE: JBE_VAC_23-291A_MSK2.ESD

Range (PV) = 1.0287 waves, RMS = 0.2016 waves, Strehl = 0.2010
Analysis Aper: Pos[230, 224] Size[429, 430]

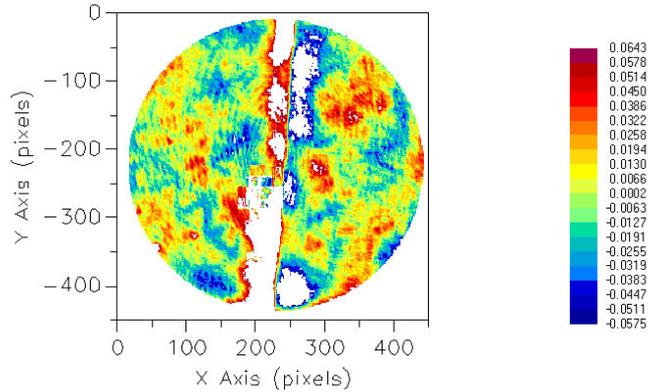
IntelliWave: Surface Map [4AM.TMD]
Date Acq: 04/02/02, 15:53:10
FILE: JBE_VAC_23-291A_RES_CLIP.ESD

Range (PV) = 0.1218 waves, RMS = 0.0235 waves, Strehl = 0.9785
Analysis Aper: Pos[230, 224] Size[429, 430]

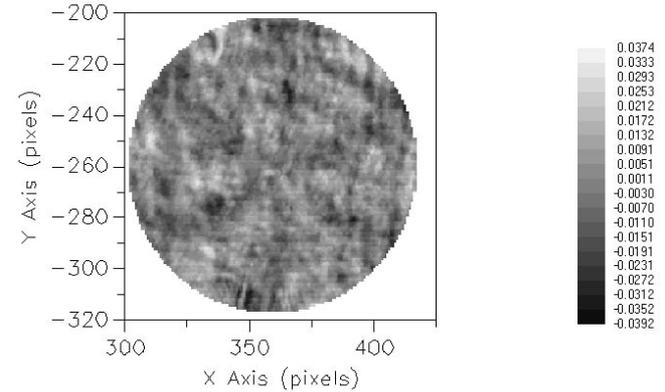
IntelliWave: Surface Map [4AM.TMD]
Date Acq: 04/02/02, 15:53:10
FILE: JBE_VAC_23-291A_MSK3R.ESD

Range (PV) = 0.0766 waves, RMS = 0.0104 waves, Strehl = 0.9957
Analysis Aper: Pos[360, 260] Size[118, 118]

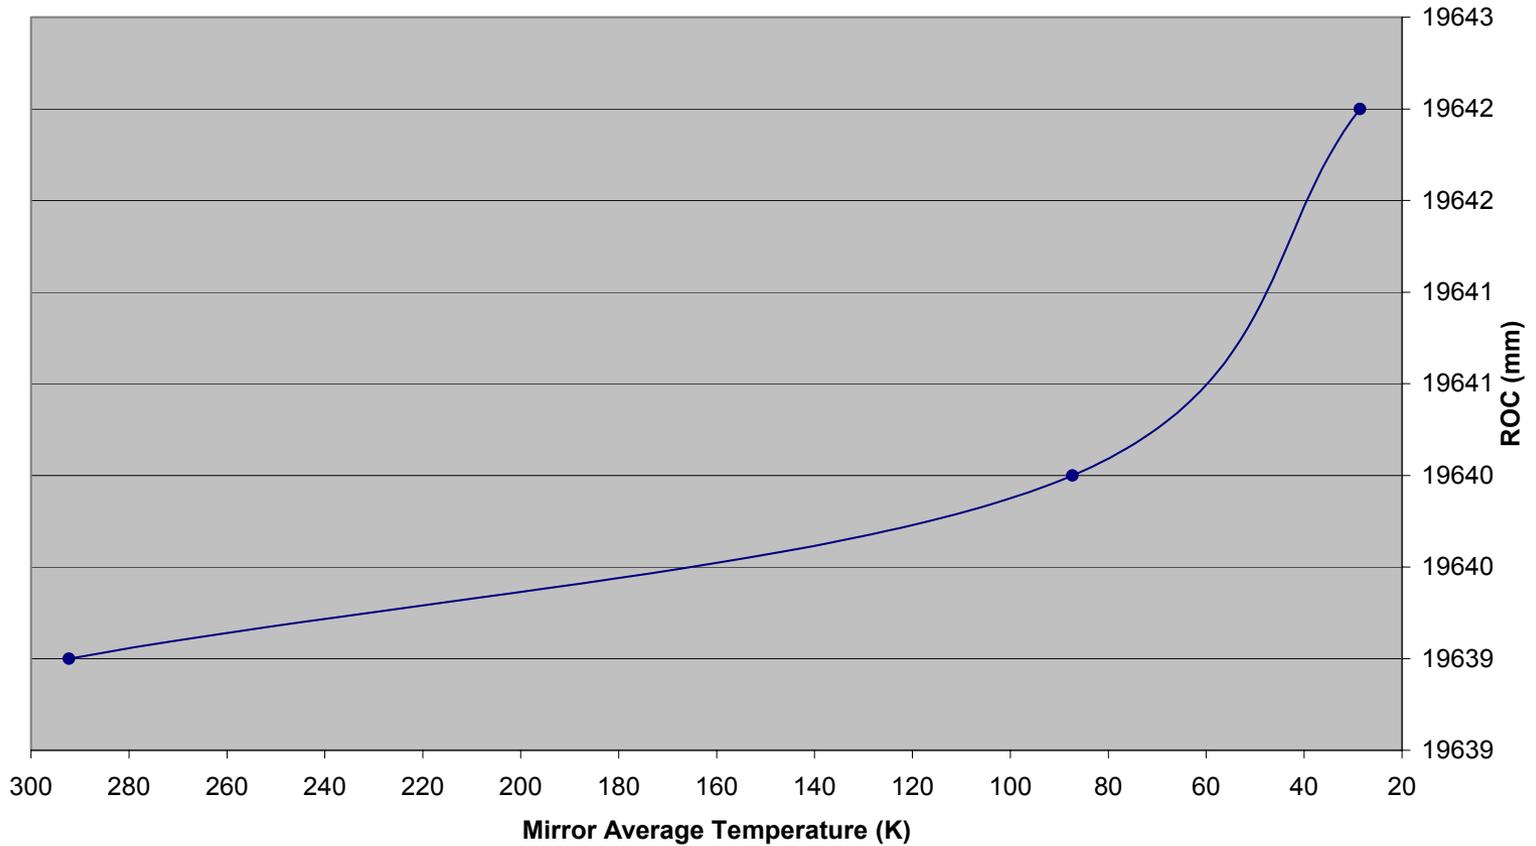
SiC RoC vs Temperature

SiC - ROC

- Change in RoC of +3 mm is within +/-6 mm error bar of measurement - would expect -6 mm change from SiC CTE.
- Changes tend to level off around 160 K, corresponding to level off of SiC CTE.
- Total surface figure change of only about 0.04 waves (25 nm) RMS. Combination of trefoil & astigmatism. Saw 81 nm RMS for SBMD.
- High-frequency surface figure change of only about 0.01 waves (6 nm) RMS, which is probably near noise limit of difference plot. Saw 16 nm RMS for SBMD. Can not see any print-thru.
- Difference of 0.014 waves (9 nm) RMS between pre & post-cryo ambient figure - trefoil. Need to check for measurement errors before concluding that a permanent change occurred.

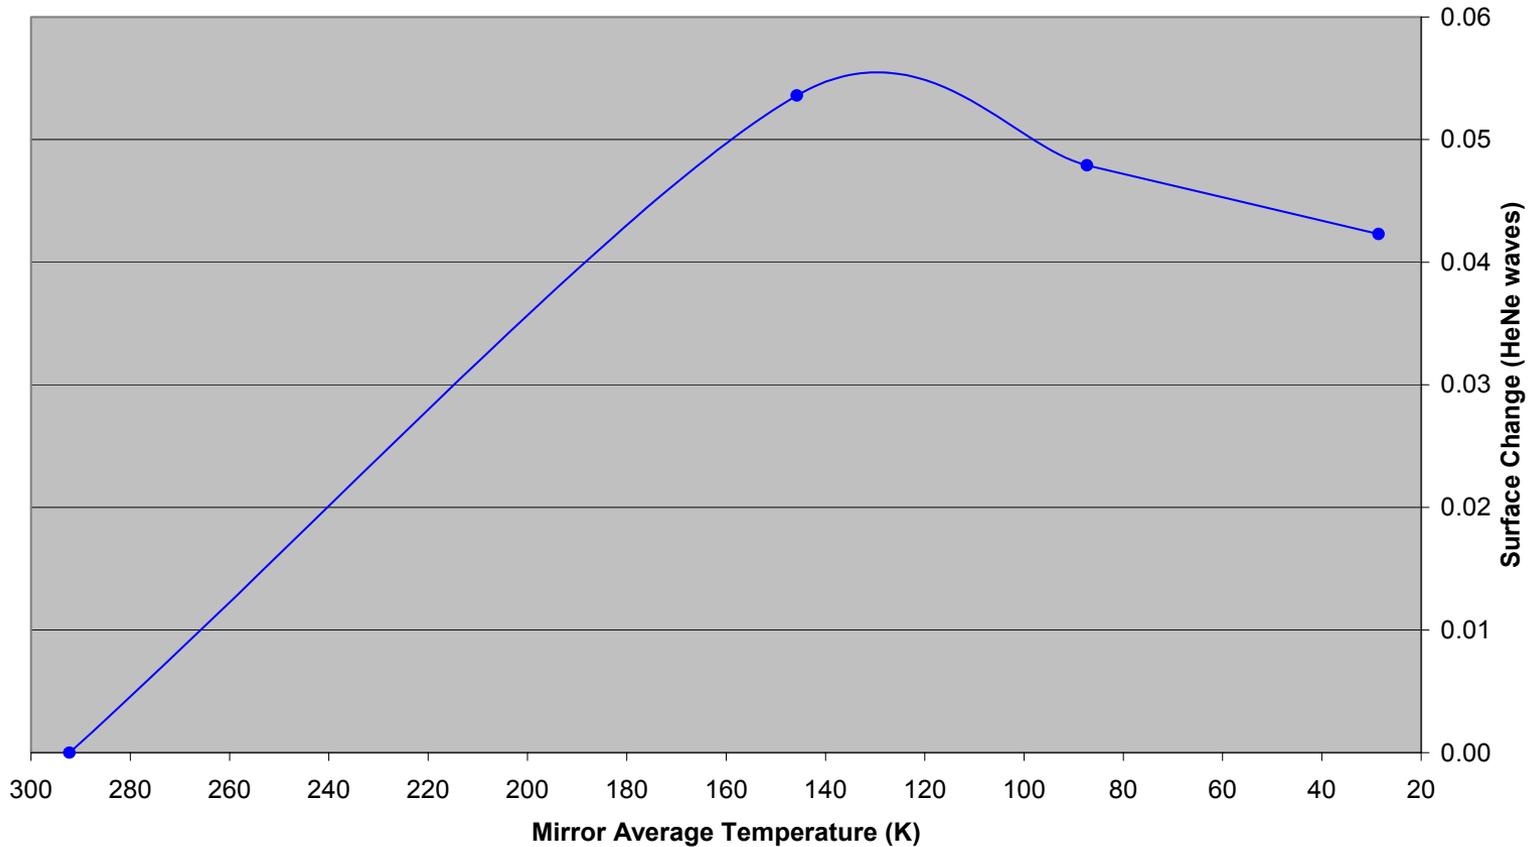
SiC RMS Cryo Deformation vs Temperature

SiC - RMS Surface Change from 293 K

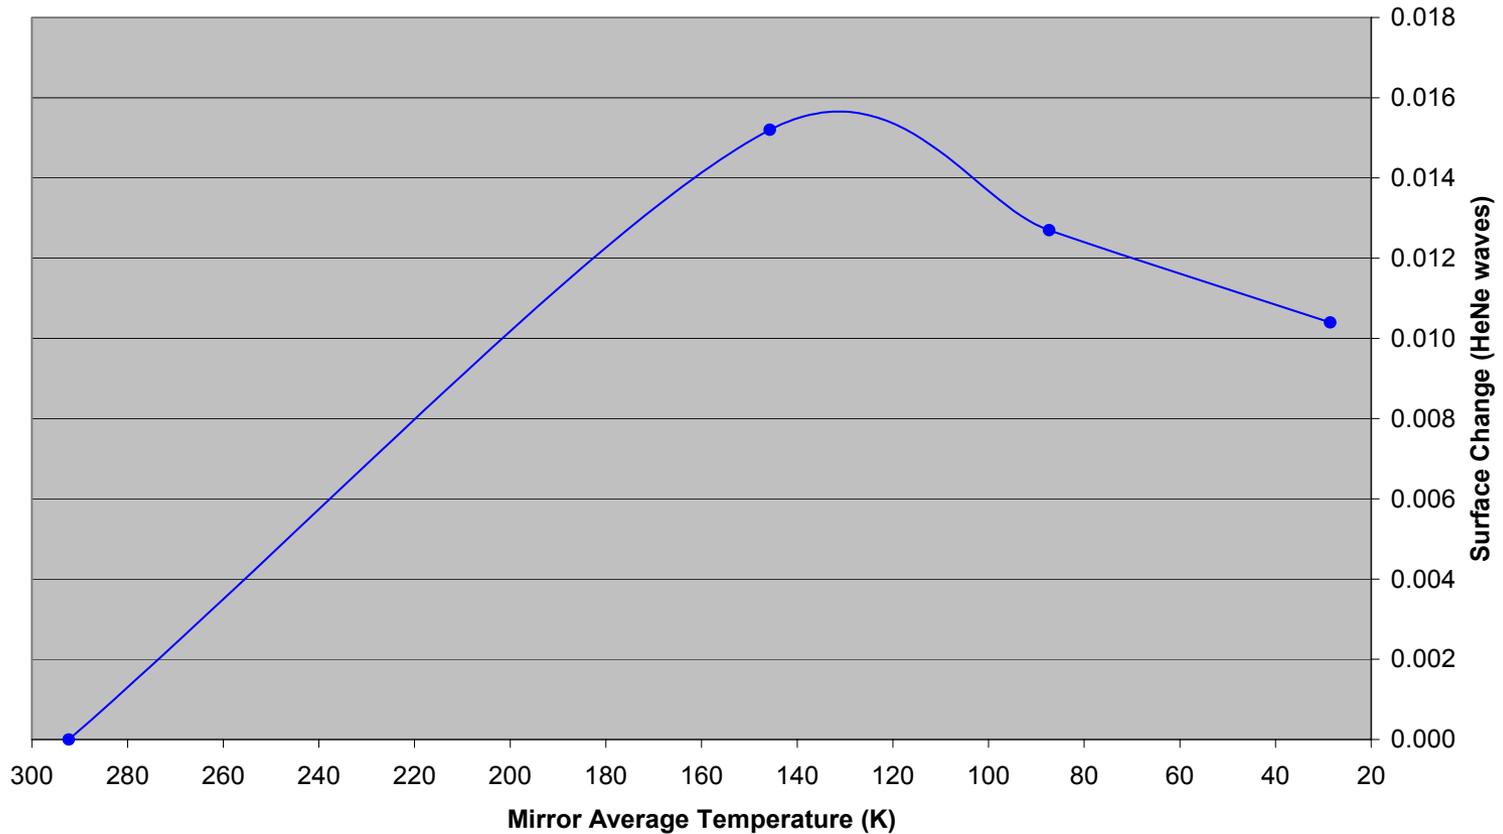
SiC RMS Residual Cryo Deformation vs Temperature

SiC - RMS Residual Surface Change from 293 K

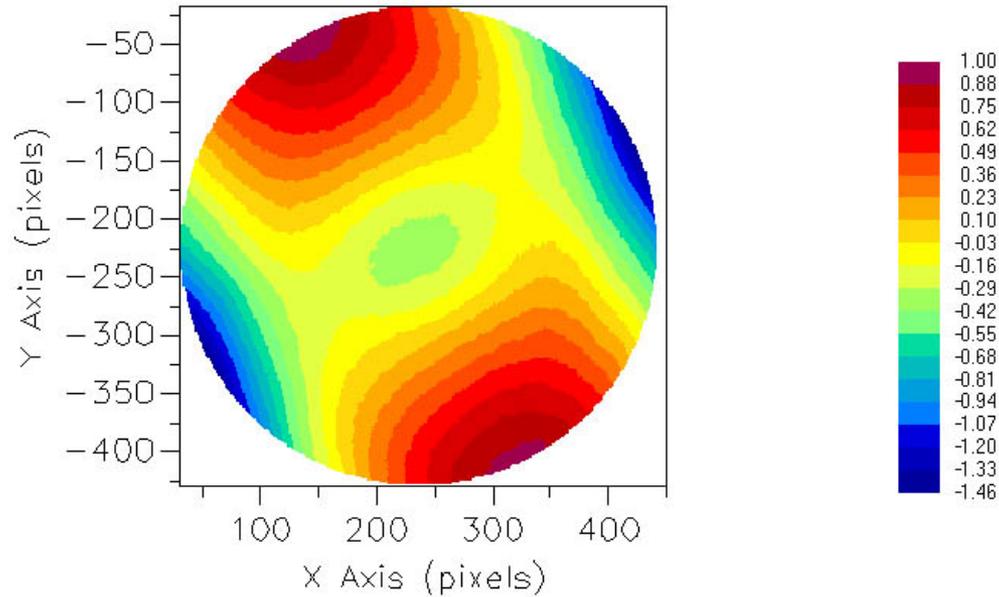
SiC Ambient Figure

IntelliWave: Surface Map [4A.M.TMD]
Date: Acq.: 04/02/02, 14:42:30
FILE: SIC_VAC_293A_REF_MSK.ESD

Range (PV) = 2.4627 waves, RMS = 0.4684 waves, Strehl = 0.0002
Analysis Aper: Pos[237, 224] Size[413, 414]

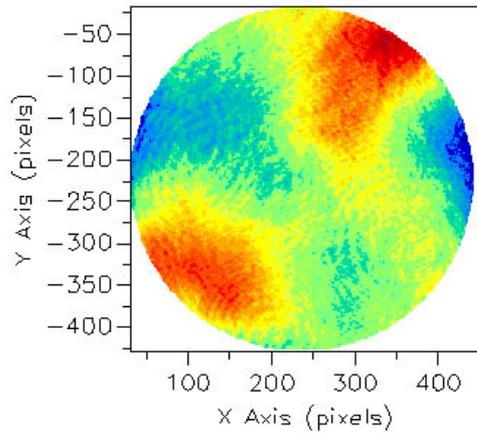
SiC Cryo Deformation

InteWave: Surface Map [4A.M.TMD]
Date: Acq.: 04/02/02, 14:42:30
FILE: SIC_VAC_30-293.AESD

Range (PV)= 0.2751 waves, RMS = 0.0423 waves, Strehl= 0.9319
Analysis Aper: Pos [237, 224] Size [413, 414]

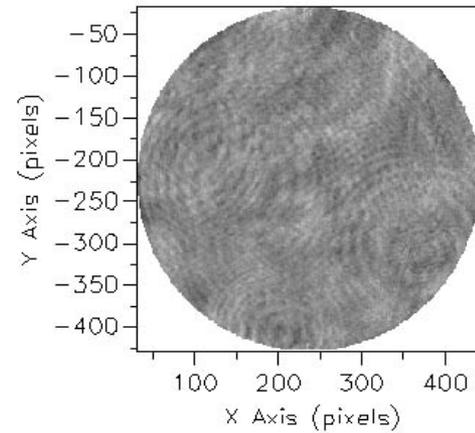
InteWave: Surface Map [4A.M.TMD]
Date: Acq.: 04/02/02, 14:42:30
FILE: SIC_VAC_30-293.AESD

Range (PV)= 0.1404 waves, RMS = 0.0104 waves, Strehl= 0.9957
Analysis Aper: Pos [237, 224] Size [413, 414]
